# Drive Belt Training

# Introduction

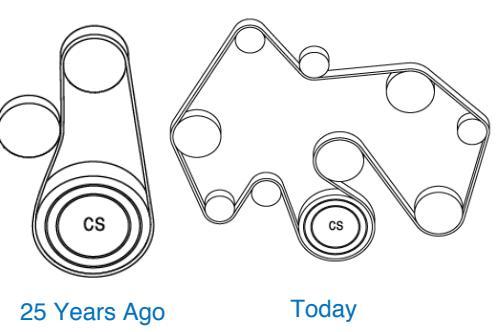
#### **BELTS 10-15 YEARS AGO**

Compound = Neoprene Life = 50,000 to 80,000 miles Failure Mode = Cracking Drive Design = Simple Application = One construction

### **BELTS TODAY**

Compound = EPDM Life = 90,000 - 100,000 miles Failure Mode = Loss of rubber material Drive Design = Complicated Application = Multiple constructions

The upside is that now only one belt is required. The downside is that if this one belt fails, the vehicle is usually stranded. For belts to last over 90,000 miles, the belt material was changed to an EPDM rubber compound, which is inherently stiffer than the older neoprene compounds. This stiffer compound can be less resistant to minor pulley misalignments and will tend to make noise if these misalignments are not corrected. This is one of the reasons that noise is a bigger complaint today especially in colder weather. Remember, if there is noise coming from the new belt, there is a reason and the majority of the time it's NOT the belt. Something is causing the belt to make noise and it's usually a misalignment or tension issue.

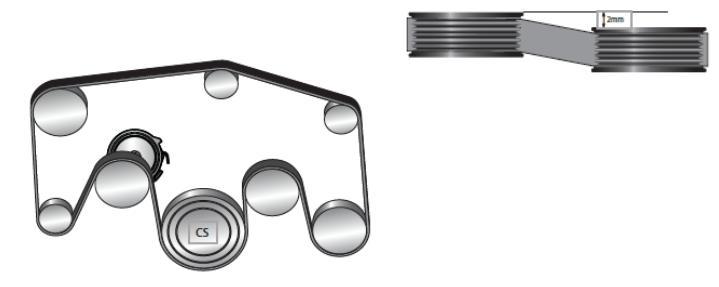
The image to the right is a demanding belt drive that is prone to make noise. Why? Notice that there is a long belt span from the power steering pulley to the backside water pump pulley, and then a very short span from the water pump pulley to the crank shaft pulley. Any misalignment between the power steering pulley and the crankshaft pulley will NOT be corrected as the belt enters the backside water pump pulley. The belt will travel around the backside pulley in the same plane that it enters, which means that the belt will have to make up the misalignment caused by a worn-out water pump bearing, will create a higher force on one side of the belt ribs as it is being forced into the crankshaft pulley grooves, thus creating a likely condition for noise to occur. This application is known for both misalignment caused by a worn water pump pulley and bearing pulley being out of plane, and (2) a misalignment caused by a worn water pump pulley and bearing.

Misalignment reacts differently depending on the spans of the belt. You will notice the angle the belt is entering the pulley differs depending on the span of the belt. This is a critical element in determining noise on demanding drives such as the drive represented above.

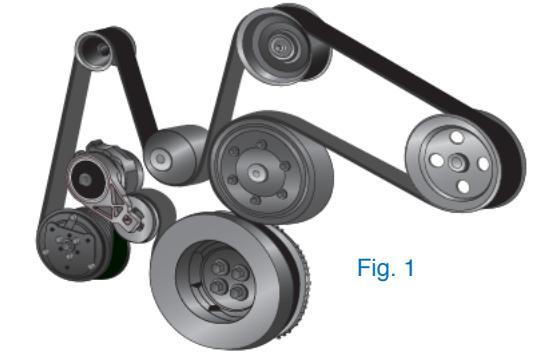
This belt drive is an example of a well designed system that is not prone to belt noise. Accessories are spaced apart without aggressive directional changes in the belt. Even though this vehicle has the exact belt part numbers as the drive mentioned above, this vehicle has virtually no complaints for belt noise.

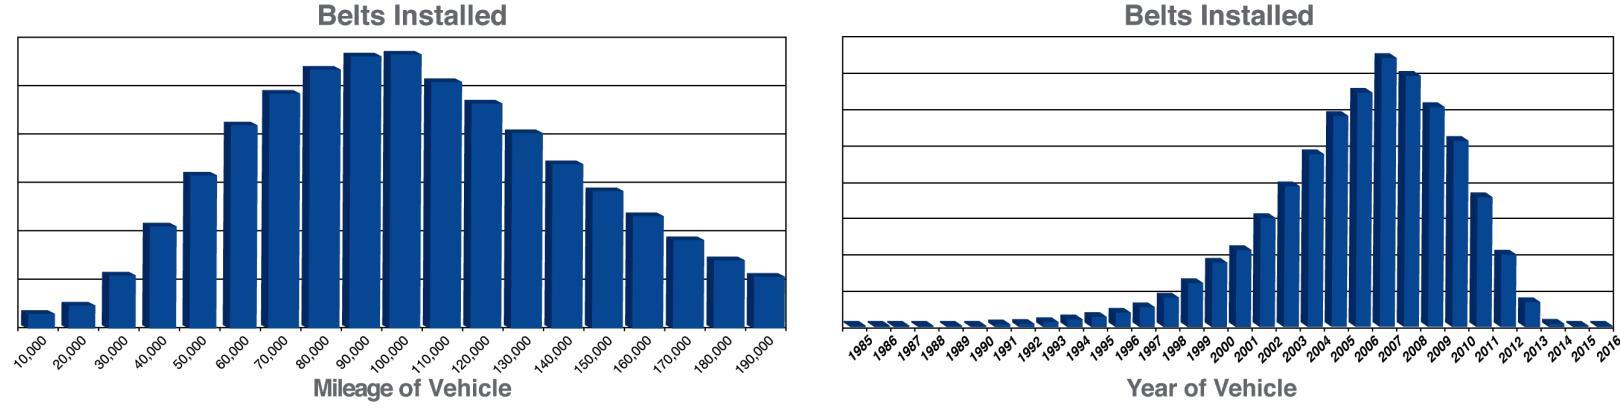
Over 80% of all belt failures and replacements occur after the vehicle passes 85,000 miles. The fact is, peak belt replacements occur between 90-100,000 miles; on vehicles that are 7 to 10 years old. Consequently, the average age of cars on the road today is nearly 10 years old with over 100,000 miles. The graphs shown below represent a study of over 300,000 belt replacements over the past 12 months. This directly identifies the target market for belt replacements.

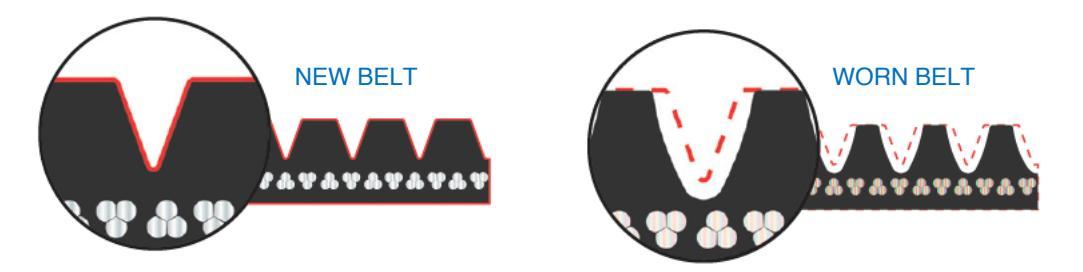
As discussed earlier, EPDM belts wear differently than the earlier neoprene constructed belts. Belt wear can be difficult to detect because they tend to wear like a tire tread, i.e. there is a material loss from the rib surface. A new EPDM belt will have a traditional "V" profile in the grooves between the ribs. With a worn EPDM belt however, the groove profile has the appearance of a "U", because of the material lost from the rib. Once the rib profile is changed, there is less material (and therefore less surface area) coming into contact with the pulleys. This material loss can cause slippage that will affect the performance of the accessories and possibly result in an annoying, noisy belt.

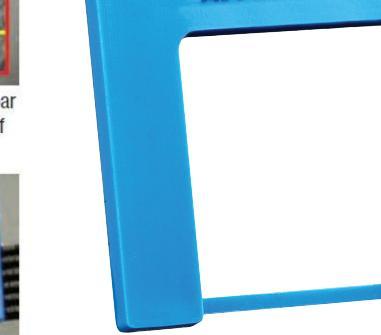
In a new belt, the top of the bar will be higher than the tops of the rib tips.

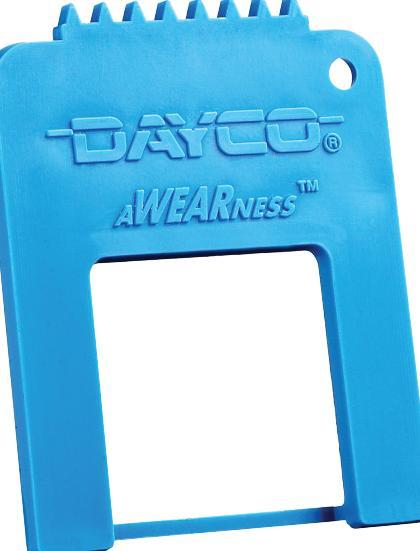
If there are four or more cracks in the window when placed flat on belt, recommend replacement.

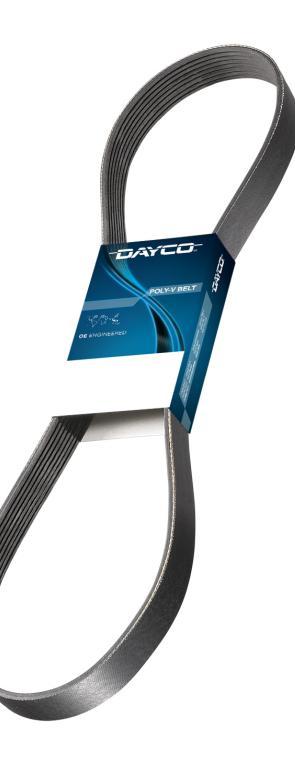
The Dayco Poly-V belt is engineered for high mileage vehicles. The Dayco Poly-V line of belts has various constructions based on the demands of the specific application. The Poly-V belt was developed by the Dayco engineering team to conform to slight misalignments in today's high mileage vehicles, without making noise. Belts are being replaced on vehicles with over 90,000 miles and they are far from perfect. The Dayco Poly-V belt offers a better solution.

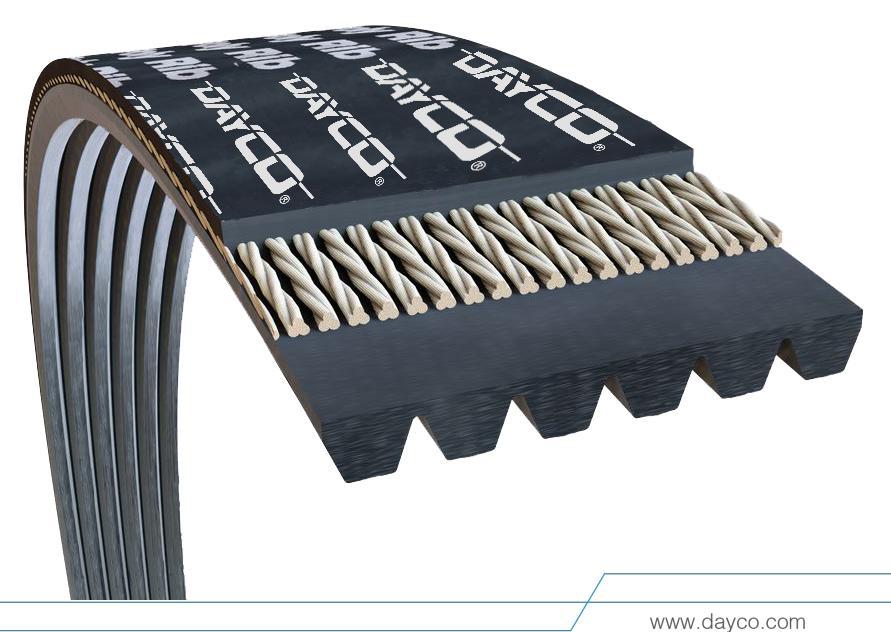
Dayco engineers have also discovered that some import applications have very sharp pulley tips which can cause premature belt rib wear, resulting in a loss of tension and ultimately serious noise issues. Dayco re-engineered these specific part numbers to incorporate a deeper rib design that eliminates the excessive and premature rib wear, allowing for improved tension maintenance properties, thus insuring peak, quiet performance.

- Engineered to maintain a quiet, vibration-free belt drive system
- Designed to maintain required belt tension over the life of the belt and resist elongations
- Designed to elongate over the pulley system, maximize belt life and load carrying requirements
